## SUMMARY REPORT

Agreement RFQ No. 456-11637  
City of Fort Lauderdale Project No. P12212  
Task Order No. 1 Seawall Master Plan

BCC Engineering, Inc.  
Certificate of Authorization No. 7184

February 5, 2018

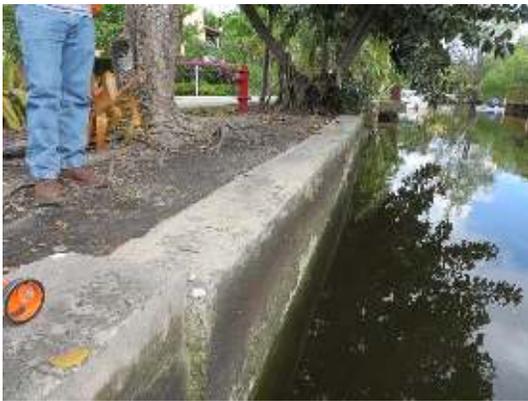
- 1) External (global) stability. Signs of overall distress or loss of stability threatening property adjacent to or behind the seawall.

**Figure 2.7.1 Lateral Movement/Rotation**

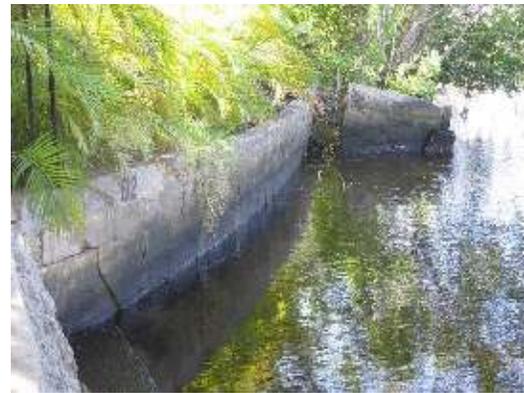
**Figure 2.7.2 Lateral Movement/Separation**

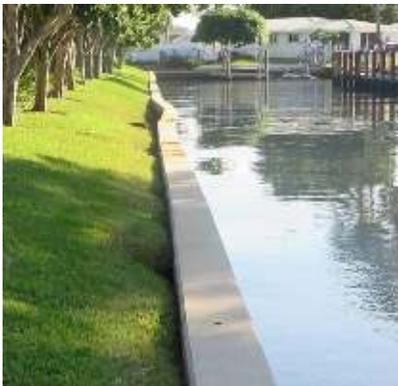
- 2) Internal (structural) stability. Deterioration or failure of a seawall component.

**Figure 2.7.3 Tie Back Failure**

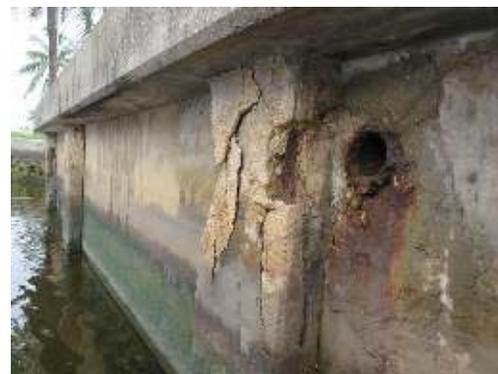
**Figure 2.7.4 T-Pile Spall and Panel Cracking**

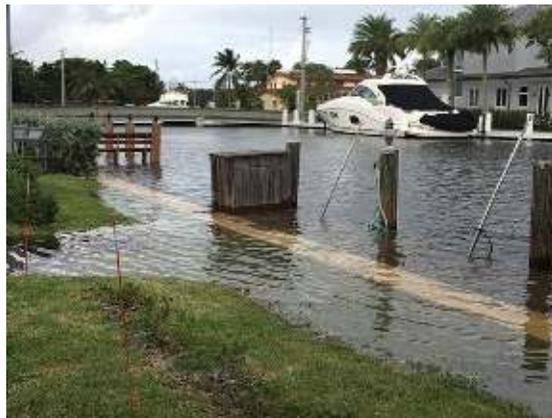
- 5) Redundancy. Any redundancy in the seawall design or construction that may render deficiencies less critical than those of a non-redundant seawall system.
- 6) Exposure/Overtopping Vulnerability. Seawalls that have increased exposure or are determined to be susceptible to overtopping. Seawalls that are currently overtopped are given highest priority.

**Figure 2.7.5 Cordova Road (Seawall No. 29) During King Tide Conditions**

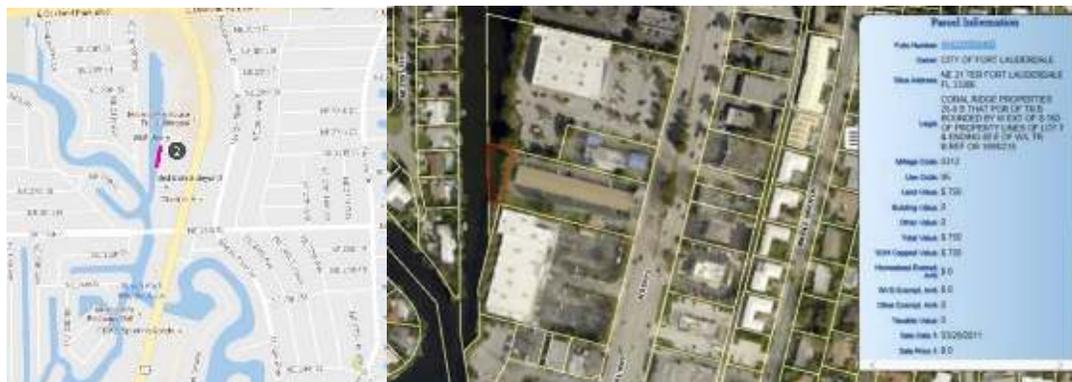
- 1) Access. Seawalls accessible by land requiring access through private property impacts construction. Seawalls accessible by water restricted by low-level bridges creates issues with equipment access. Seawall 2 (pictured below) involves both of these challenges due to a fixed bridge on NE 26<sup>th</sup> Street, restricted waterway bordering a residential area, and its location directly behind a Budget Inn.

Figure 2.8.1 Accessibility Issues – Featuring Seawall No. 2

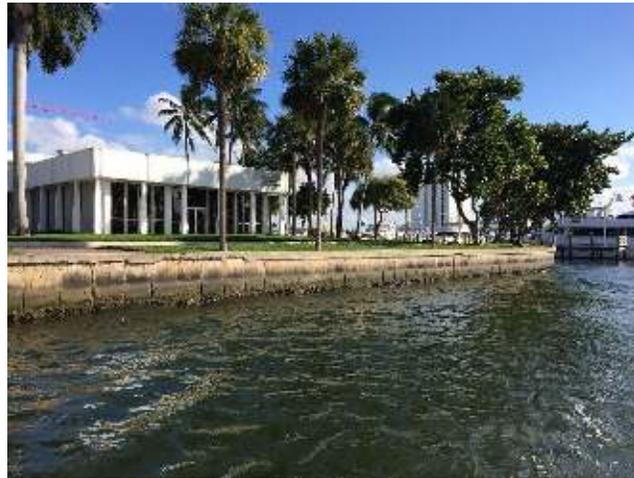
- 2) Type of property behind seawall. Many seawalls support residential and commercial properties. Minimizing impacts not only to the condition of the property but the operations and access to the property are key construction considerations.

**Figure 2.8.2 Seawall No. 19 Supports Parking and Structure Facilities**

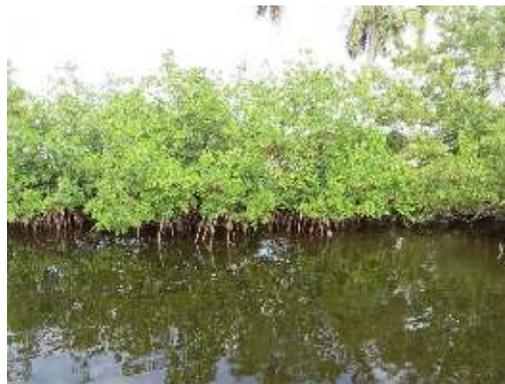
- 7) Environmental sensitivity. Presence of environmentally sensitive resources.

**Figure 2.8.3 Mangroves at the North End of Seawall No. 15**
