## SUMMARY REPORT

Agreement RFQ No. 456-11637  
City of Fort Lauderdale Project No. P12212  
Task Order No. 1 Seawall Master Plan

BCC Engineering, Inc.  
Certificate of Authorization No. 7184

February 5, 2018

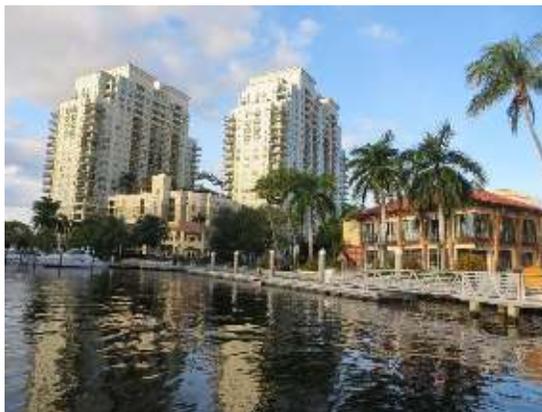
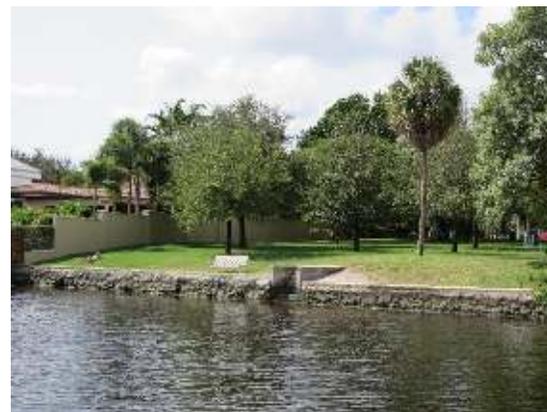
**Figure 2.7.6 Varying Importance of Seawalls**

- 7) Wall importance. General impacts should the seawall fail. In terms of impact, a seawall along a gradually sloping shoreline or park is considered relatively less important than a seawall directly adjacent to a heavily used roadway or other facility/property that would threaten public safety or commerce. The use of the waterway also factors into the seawall importance.

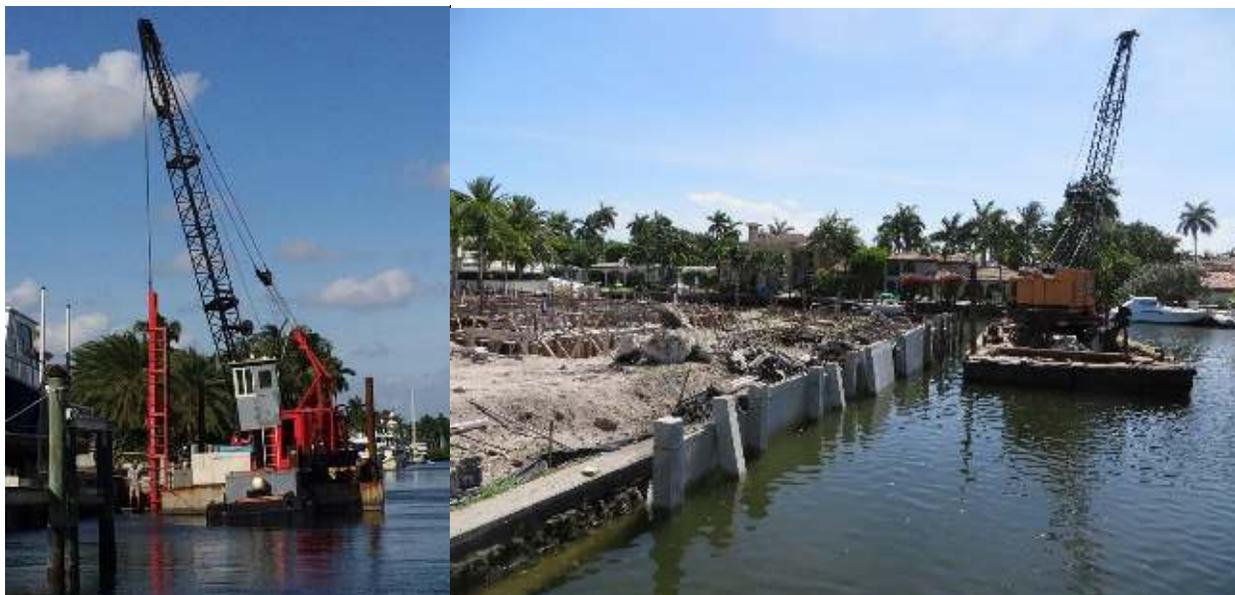
Figure 4.10.1 Conventional Seawall Installations

The most effective method to replace existing seawalls without compromising the properties behind the seawalls is to bury the walls in place using a seawall comprised of sheet piling tied together at the top with a reinforced concrete cap or precast panels and piling installed immediately in front of the existing wall. Sheet piles can be fabricated from concrete, aluminum, fiberglass, and steel. Aluminum and fiberglass offer increased corrosion resistance which is critical in the harsh environment surrounding the

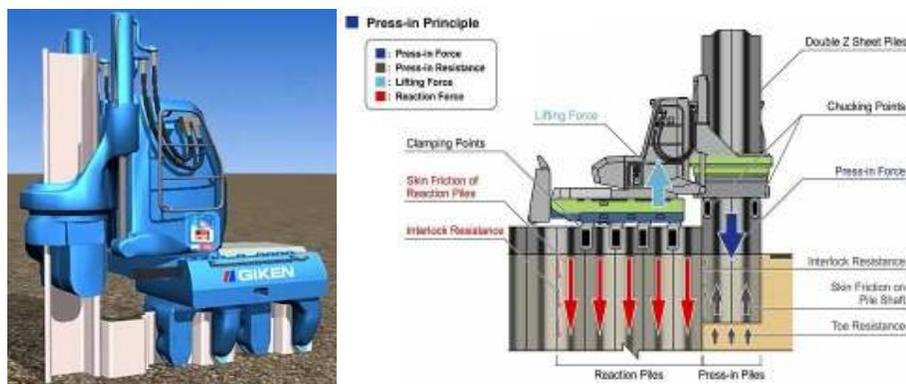
Figure 4.10.2 Press-In Sheet Pile Method

seawalls. Steel sheet piles are more commonly installed than aluminum or fiberglass sheet piles. Available means for dealing with the corrosion of the steel include cathodic protection systems, epoxy coatings and additional sacrificial thickness to increase the life span of steel sheet pile seawalls. However, sheet piles of these various materials in the height range required for the City’s seawalls would require corrugated shapes and would alter the visual appearance of the current seawalls and require consideration on a case by case basis. These types of seawalls may be cantilevered, tie back, or utilize a king pile/battered pile configuration for additional lateral support. Conventional seawall installations are performed using water-based equipment. An innovative alternative to conventional equipment is the Press-In method where conditions and constraints preclude a conventional installation. Reference Appendix A.
